Kensico Reservoir – After Gunderboom® RPS™ Deployment

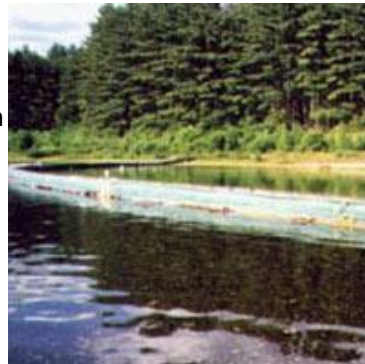
Kensico Reservoir, New York. In early January 1999, shortly after a Gunderboom RPS™ was installed at Kensico Reservoir, heavy runoff from a 50-year storm flowed into the reservoir. Normally even a small seasonal rainstorm would cause a water utility's intake to exceed Environmental Protection Agency (EPA)-mandated pathogen levels. By enclosing a cove that received high runoff, the RPS™ enabled the reservoir to meet water quality standards.

Outside Boom	Inside Boom	Reduction
Total Suspended Solids (mg/L)	9.9	0.7	92.9%
Turbidity (NTU)	20.0	1.0	95.8%
Coliforms (MPN)	>2400	22.0	99.1%
